DECEMBER 18
TAP110

FORD PX3 RANGER & EVEREST 06/2018-ON TOW POINT INSTALLATION - RP-RAN02

Applicable to vehicles manufactured post JUNE 2018.

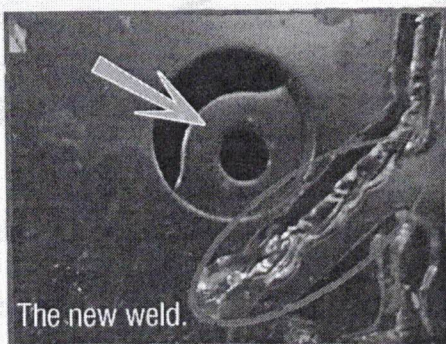
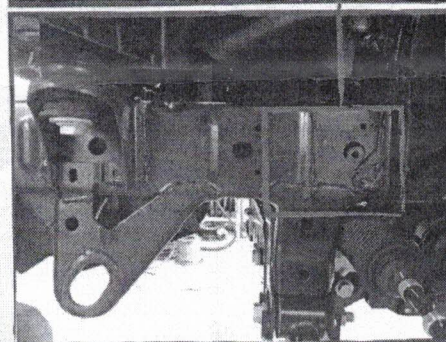
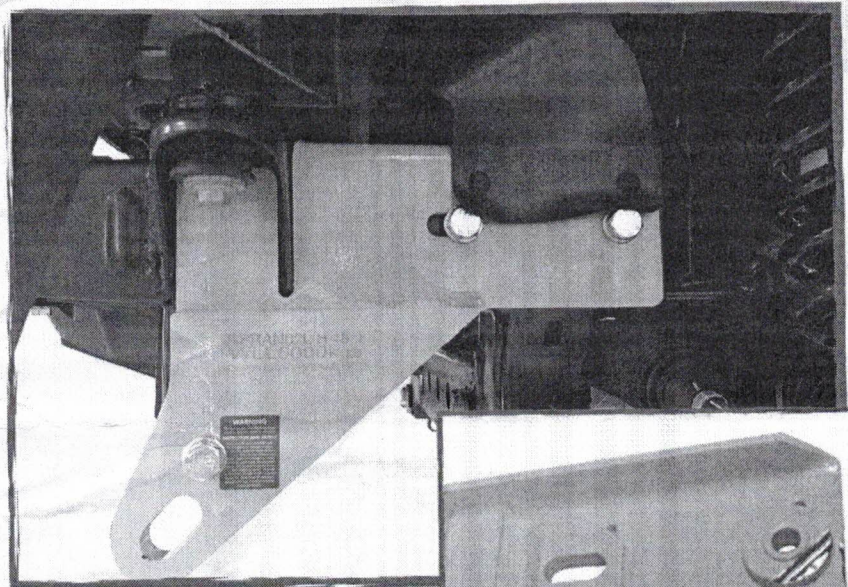
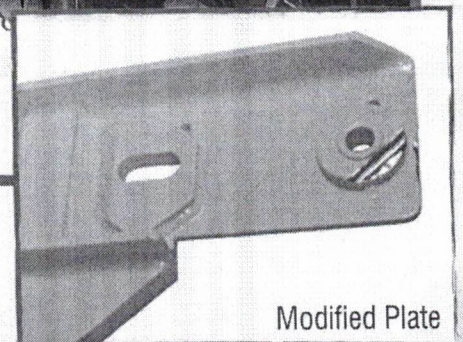
A stiffening plate installed inside the chassis rail affects access to one hole used in the fitment of RP-RAN02 (Refer Image). Using a step drill enlarge this hole to allow fitment of the supplied hardware. The spacer pictured will require modification to clear the new weld not present on previous vehicles.

The nut plate will sit behind the stiffening plate, with the bolt passing through.
